Sediment Transport/Debris Flow Analysis

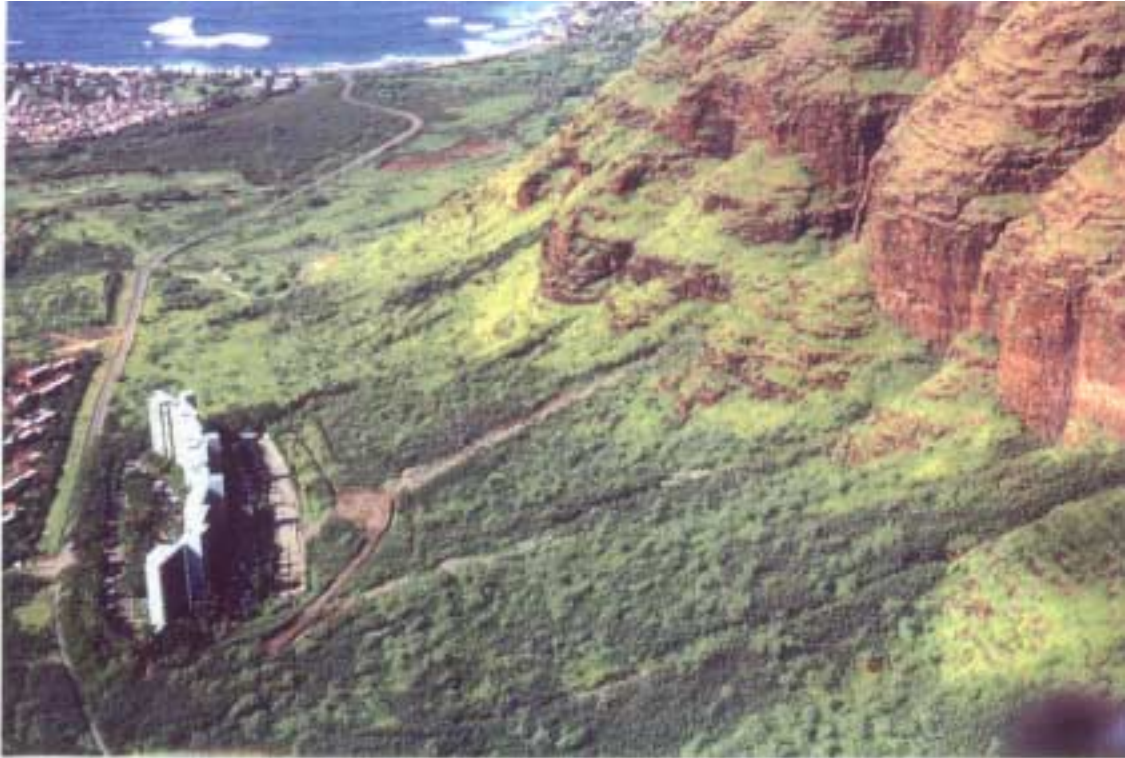
- **In this case, a massive debris and sediment load was transported, during a very severe storm, from the natural watercourse and deposited at a five-tower condominium complex located in Hawaii. Considerable damage resulted.**

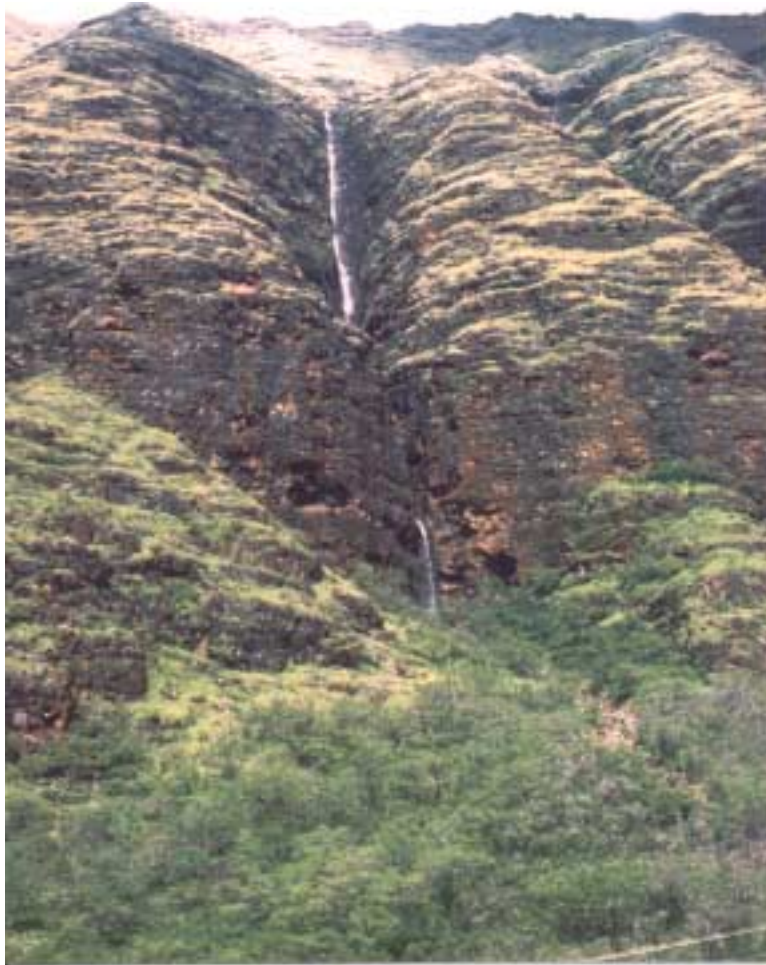
Source of Sediment/Debris

- **The ultimate source of the sediment and debris was the natural steep terrain located upstream of the complex.**

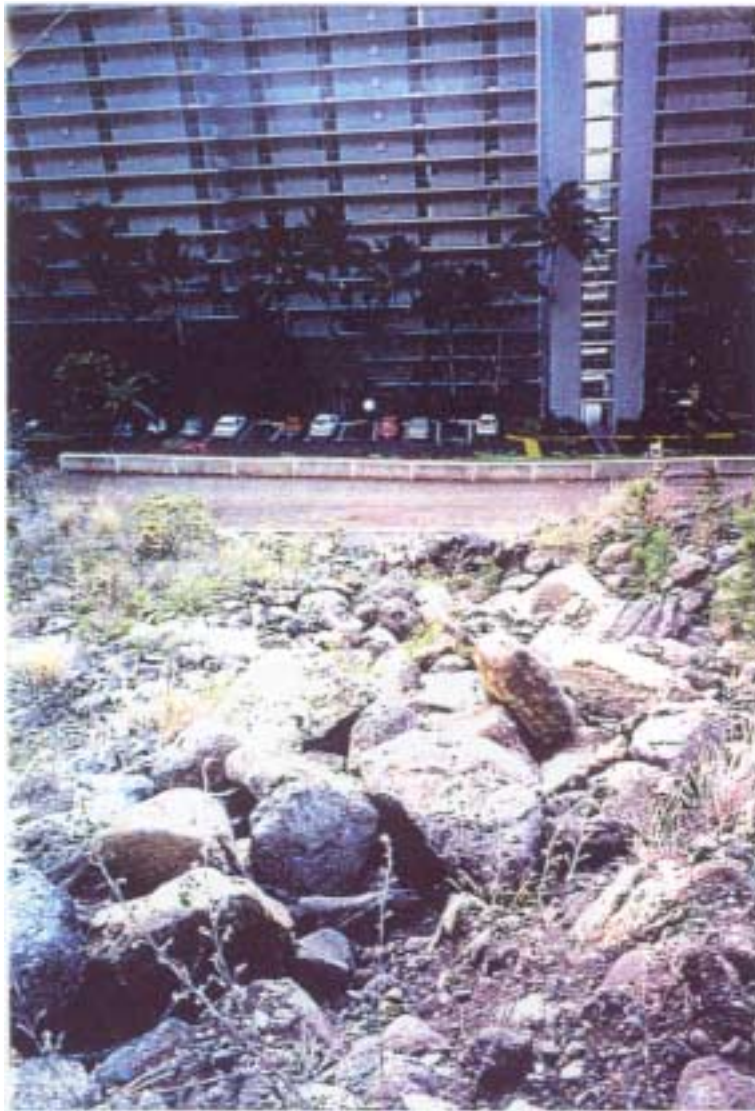
Debris Wall Behind Resort

- **Remnants of the sediment/debris flow are still evident after the clean up. A debris barrier has been placed in the parking lot of the complex.**
