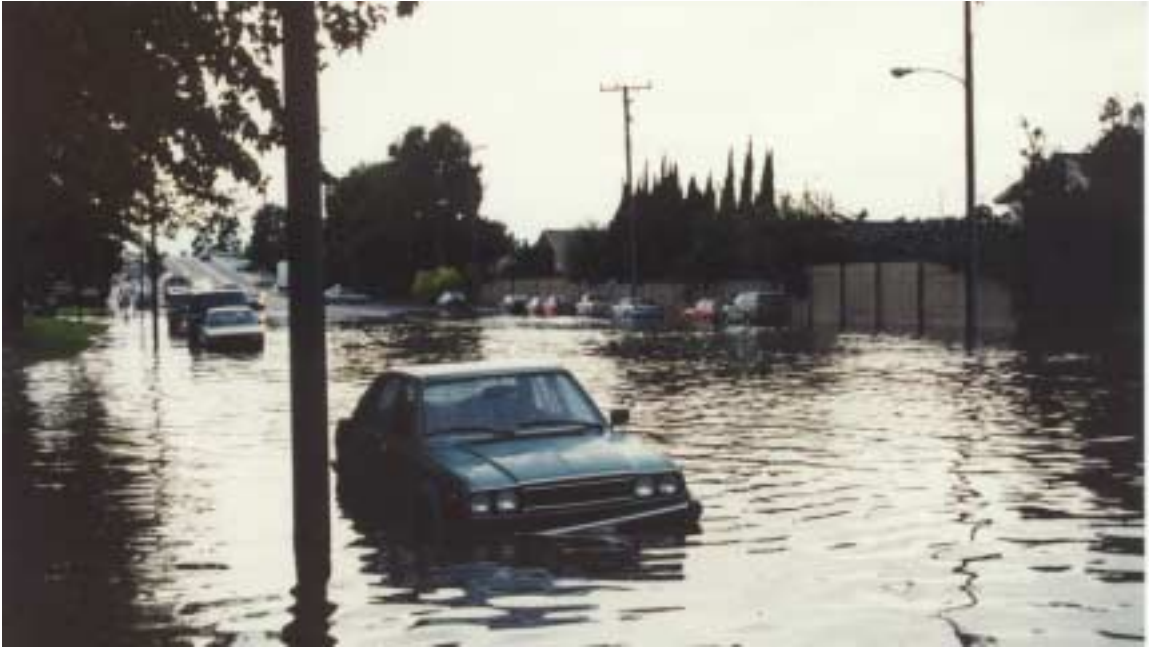
- **Flooding of streets at the entrance to the apartment complex under study.**
- **A key element in determining causation factors of flood damages is the identification of the source of the flood waters. Possible factors include the surface configuration, topographic flow, water flowing in the streets due to inability to enter flood control systems, or channel outflows.**

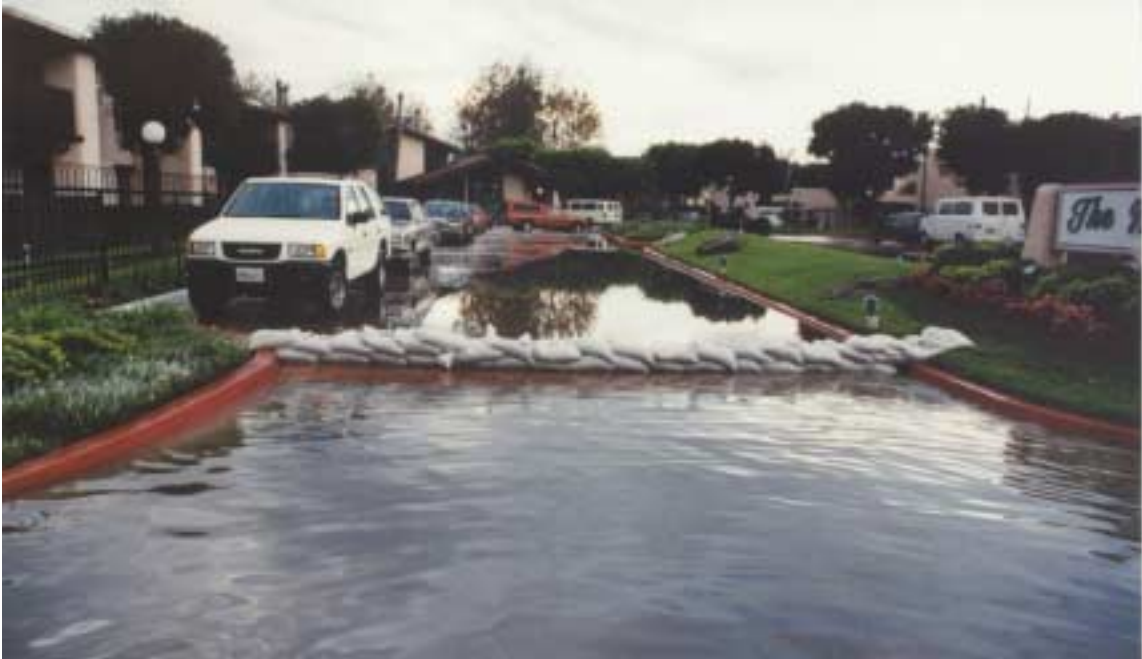
- **Sandbags were placed at the northerly entrance to the subject apartment complex in order to prevent flows from entering the complex.**

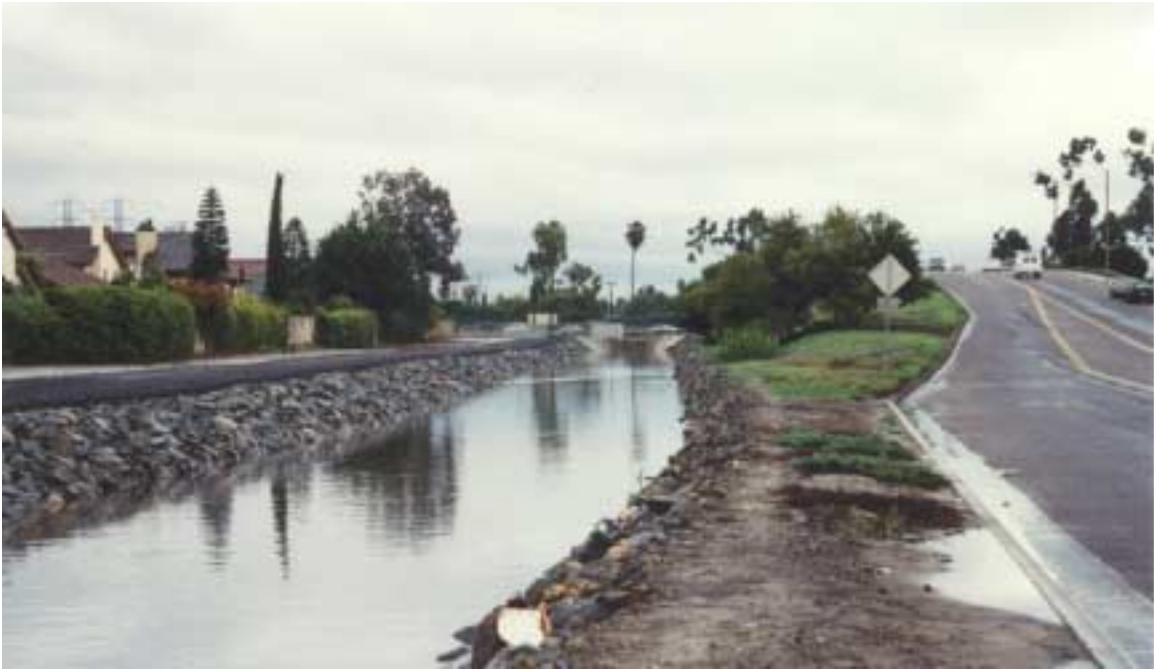
- **A major channel located near the subject apartment complex was alleged to be a source of flood waters. The subject apartment complex is located to the right of this photograph.**
- **The adjacent roadway is seen to be elevated over a freeway. The freeway is of higher elevation than the subject apartment complex. The roadway is on the east side of the complex.**

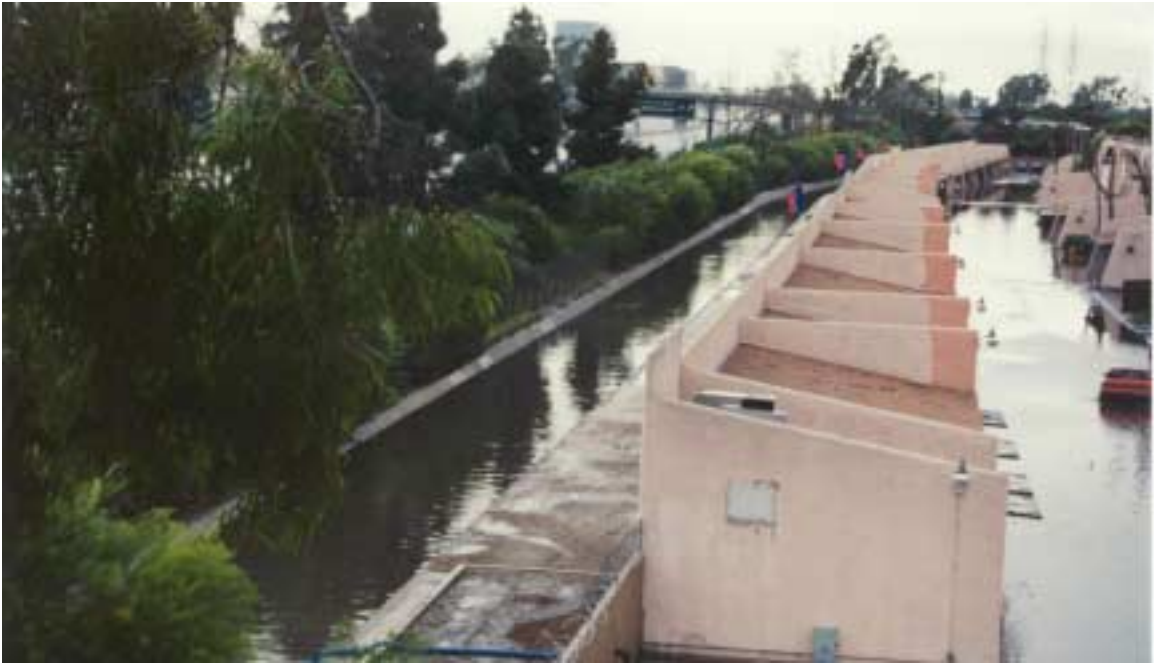
- **Another channel located behind the subject apartment complex was also alleged to be a source of flood waters.**
- **Other causation factors examined included the severity of the storm, urbanization effects, and issues involving a failed levee of a flood control channel as well as other factors.**
